# UNDERWATER BRIDGE INSPECTION REPORT

STRUCTURE NO. 2441  
FRANKLIN AVENUE (CSAH NO. 5)  
OVER THE  
MISSISSIPPI RIVER  
DISTRICT 5 - HENNEPIN COUNTY

PREPARED FOR THE  
MINNESOTA DEPARTMENT OF TRANSPORTATION  
BY  
COLLINS ENGINEERS, INC.  
JOB NO. 3512 (CEI 121)

MINNESOTA DEPARTMENT OF TRANSPORTATION  
UNDERWATER BRIDGE INSPECTION

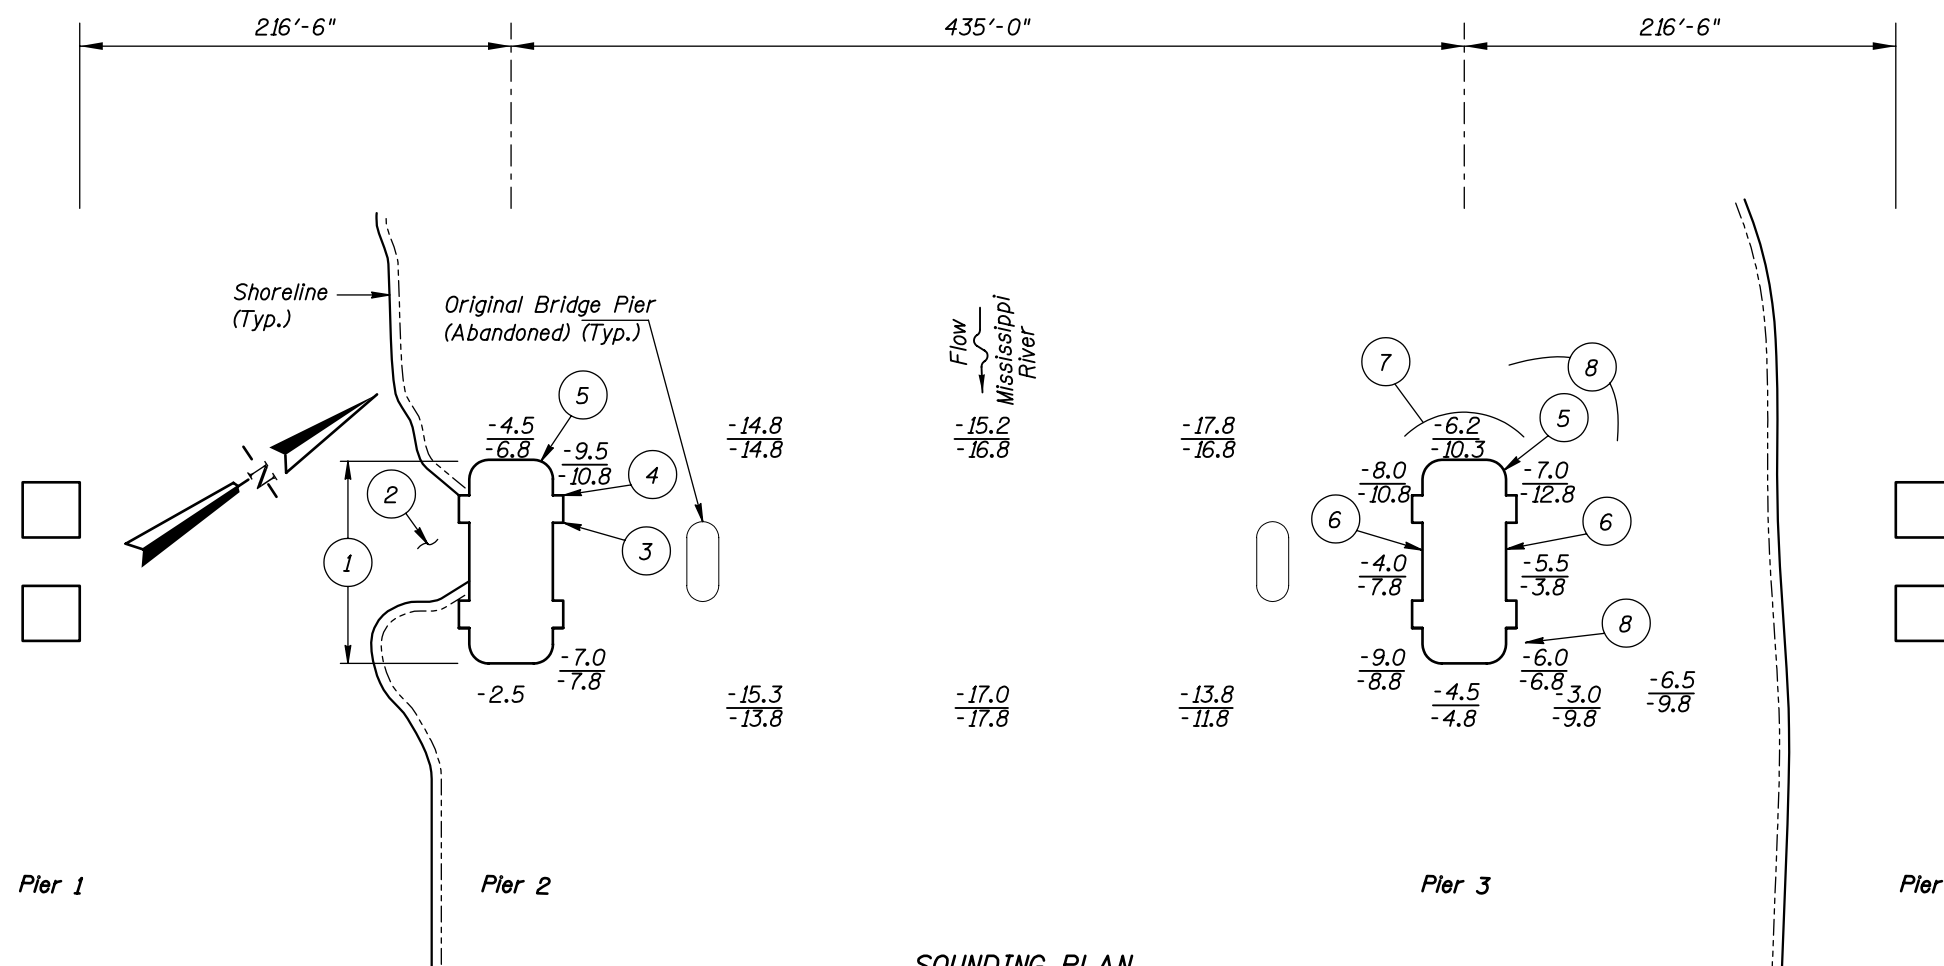
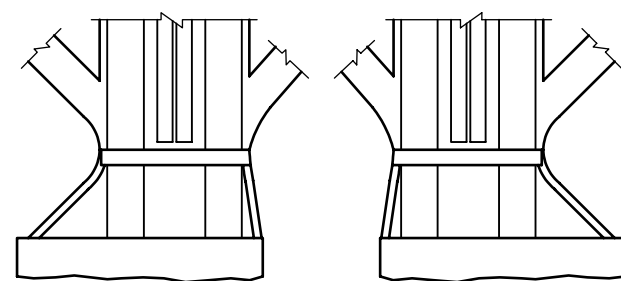
**INSPECTION AND SOUNDING PLAN**

- 1 The concrete along the west face of Pier 2 was in fair to poor condition with extensive scaling and areas of section loss observed from approximately 4 feet above the waterline to the channel bottom. Typically, the areas of section loss exhibited exposed heavily corroded reinforcing steel and up to 1 foot of penetration.

- 2 Accumulation of concrete rubble and steel debris was observed around Pier 2 and extended approximately 1 foot above the waterline along the west face of the pier.

- 3 An area of section loss with exposed reinforcing steel was observed from 4 feet above the waterline to approximately 4 feet below the waterline with up to 8 inches of penetration.

- 4 An area of section loss with exposed reinforcing steel was observed from 4 feet above the waterline to approximately 5 feet below the waterline with up to 12 inches of penetration.

- 5 Typically, Piers 2 and 3 exhibited heavy scaling from 1 foot above the waterline to the channel bottom with areas of exposed reinforcing steel and up to 8 inches of penetration.

- 6 Heavy scaling was observed from 4 feet above the waterline to the waterline along the middle portion of the pier along both faces with exposed reinforcing steel and up to 10 inches of penetration.

- 7 Large diameter riprap has been stacked up in front of the upstream nose of Pier 3.
- 8 Rocks and boulders were observed on the channel bottom along the east side of Pier 3.

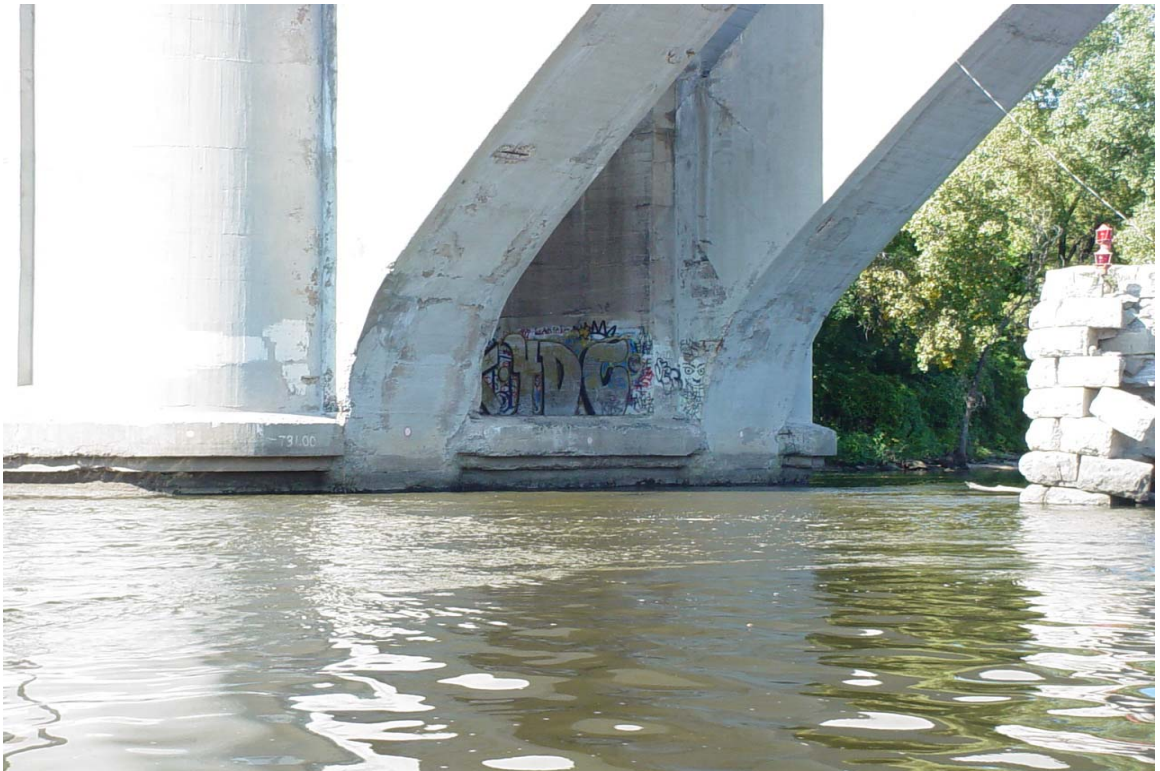
Photograph 2. View of Pier 2, Looking Northwest.

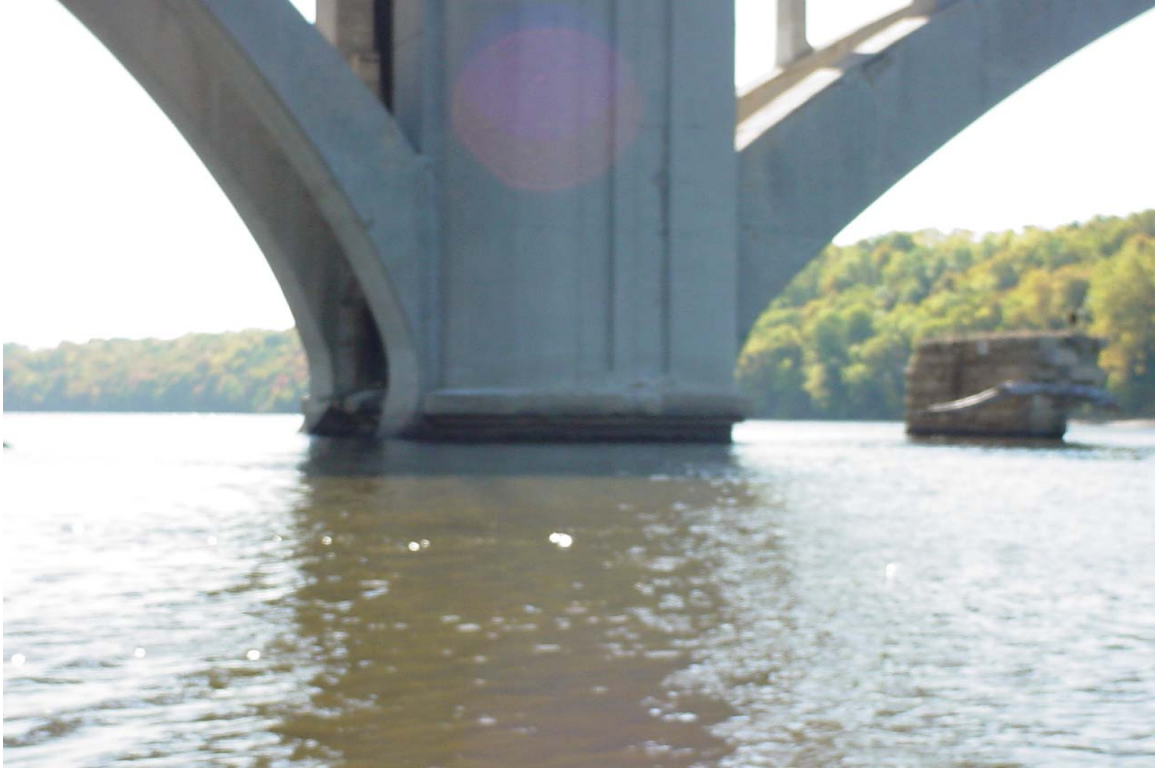
Photograph 3. View of Pier 3, Looking Southwest.

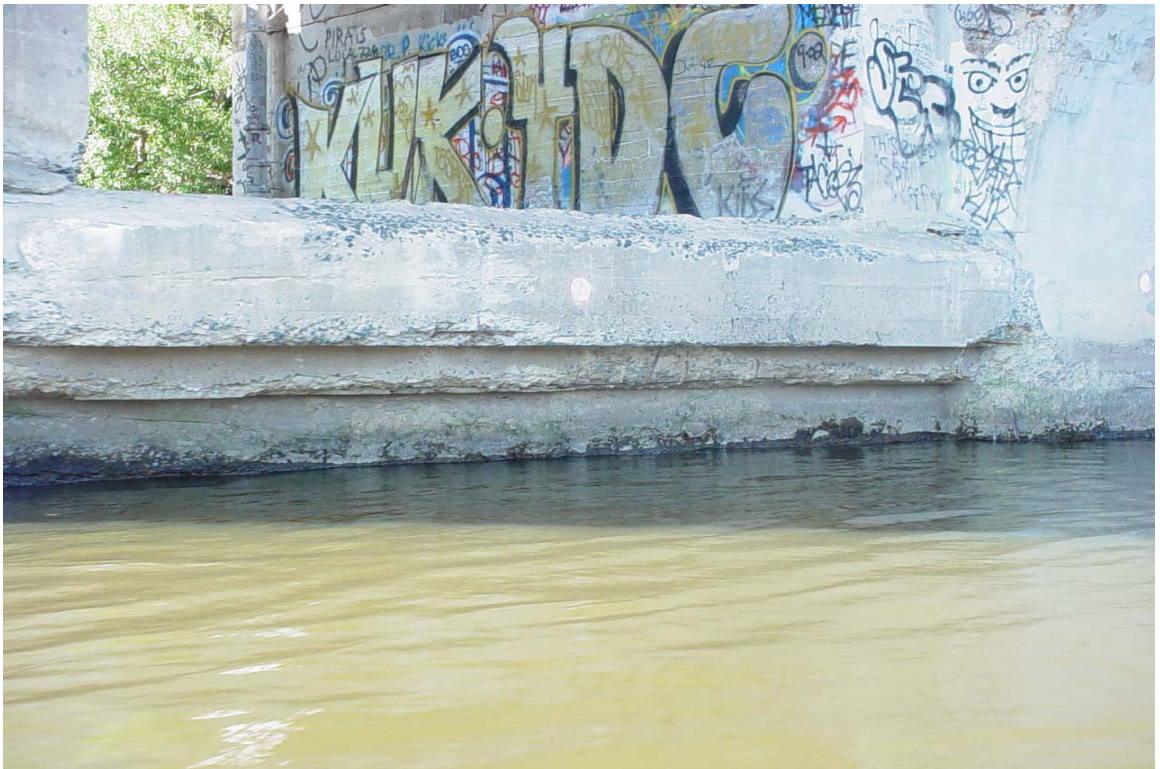
Photograph 4. View of Heavy Scaling and Section Loss at Pier 2, Looking Northwest.

- (A) The deterioration with exposed reinforcing steel should be addressed before it progresses and becomes more detrimental. At the minimum, the exposed reinforcing steel should be cleaned and covered with an epoxy grout. Due to the significant loss of concrete section, however, a more desirable repair would be to remove all loose and unsound concrete, clean the exposed reinforcing steel, and reform the shaft to the original dimensions and lines with a concrete mix designed for underwater applications.
- (B) Reinspect the submerged substructure units at the normal maximum recommended (NBIS) interval of five (5) years.

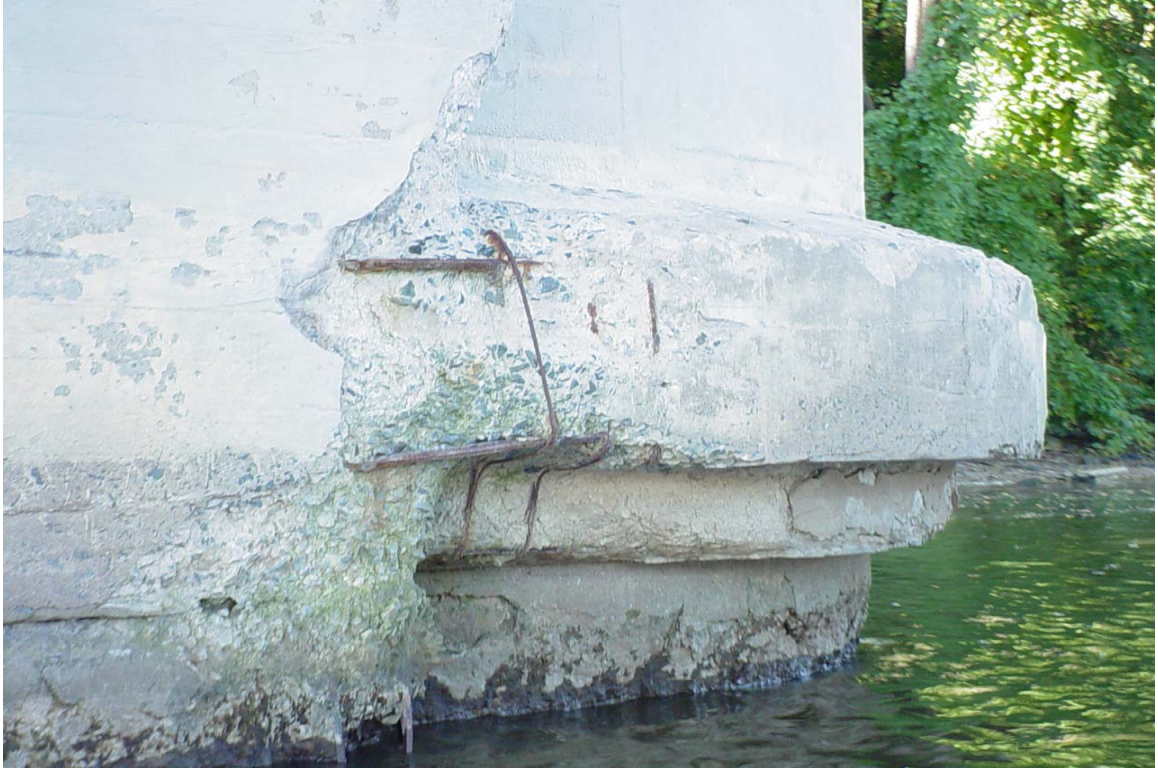
Photograph 5. View of the Upstream End of Pier 2, Looking Northwest.

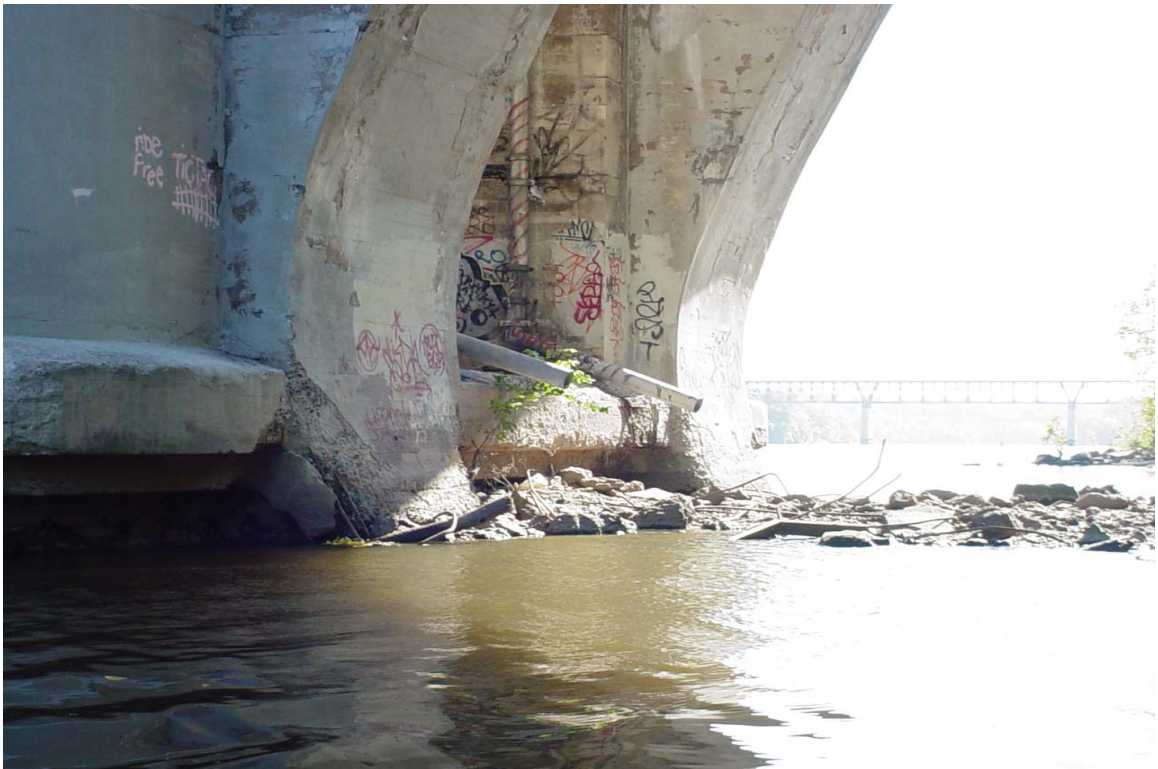
Photograph 6. View of Deterioration Along the West Side of Pier 2, Looking South.

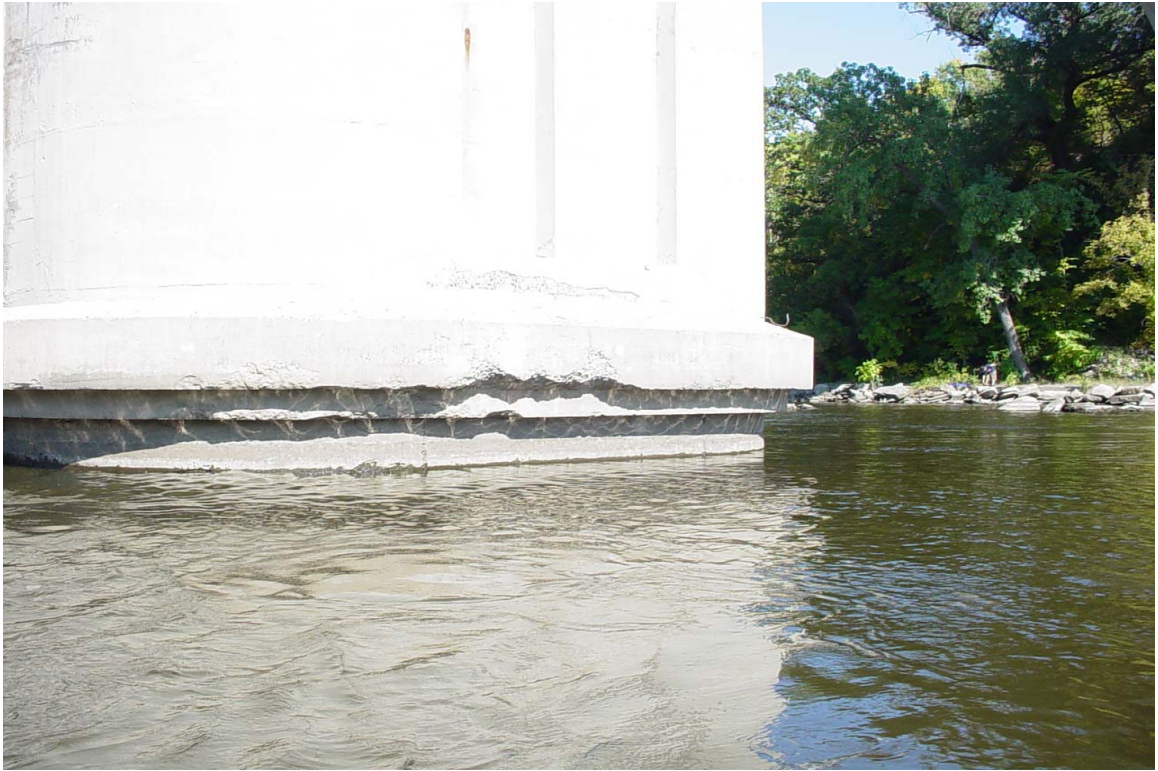
Photograph 7. View of the Upstream Nose of Pier 3, Looking Northeast.

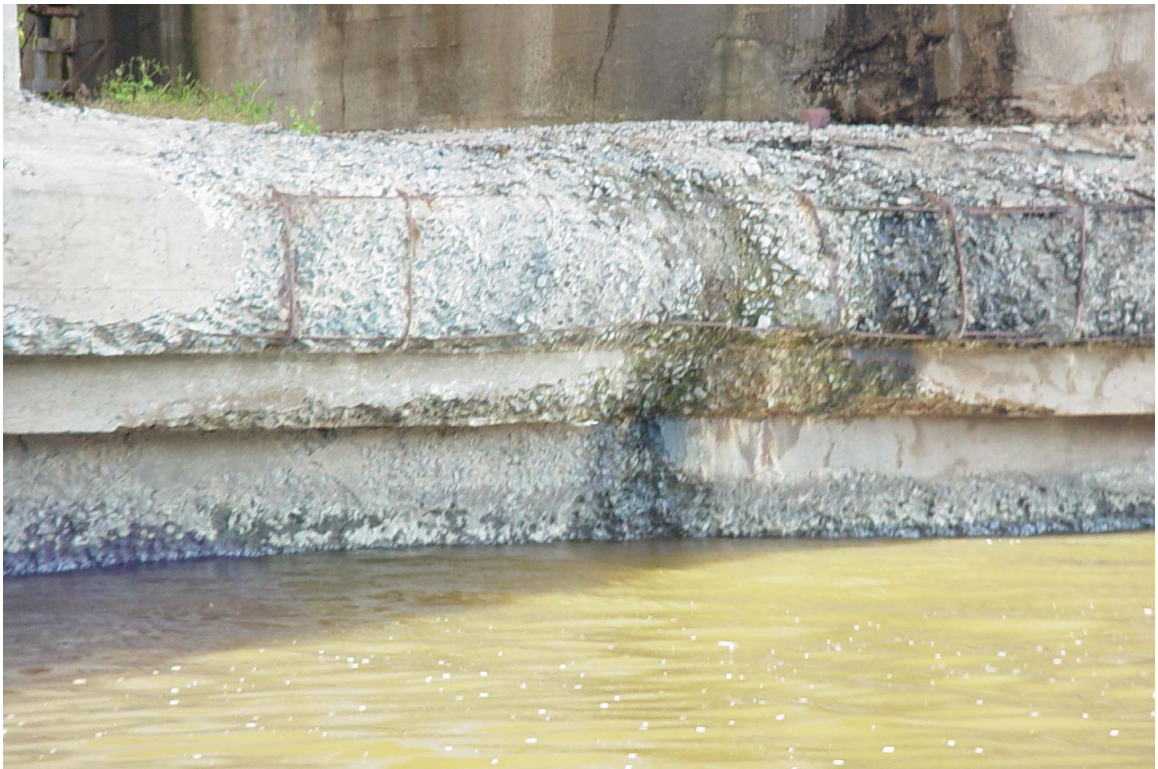
Photograph 8. View of the Heavy Scaling and Section Loss Along the West Side of Pier 3, Looking East.

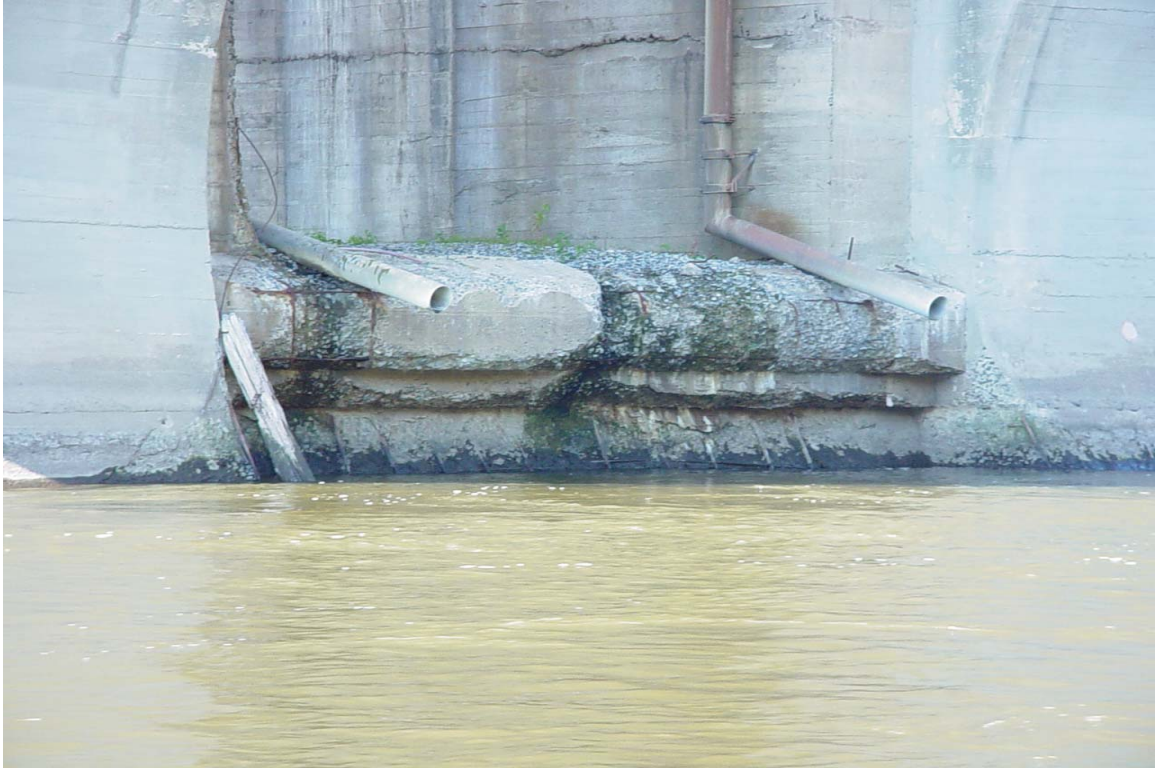
Photograph 9. View of the Heavy Scaling and Section Loss Along the East Side of Pier 3, Looking Northwest.
